Public Works Committee Agenda

Village of Whitefish Bay

Private Property Inflow-Infiltration (PPII) Reduction Program

November 30, 2016

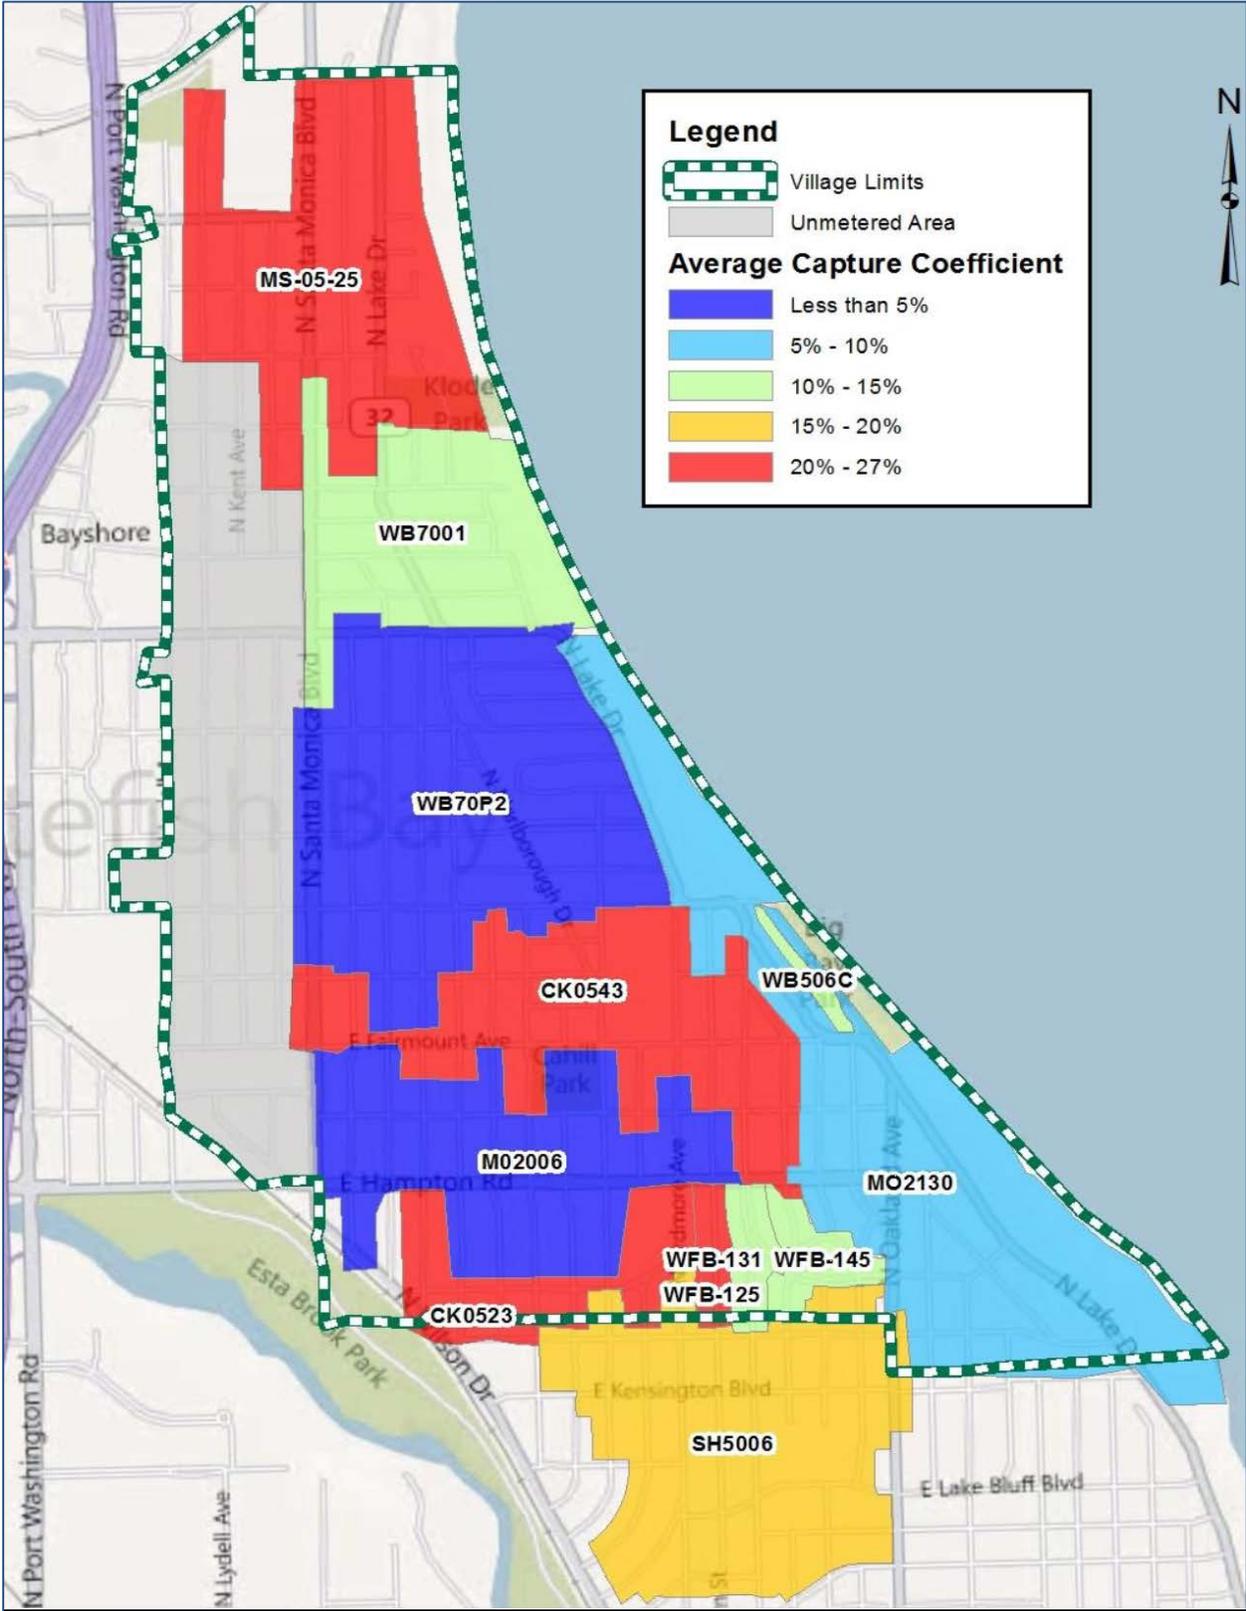
Figure 1 - Inflow Potential Summary

The results of the inflow analysis are summarized in Figure 1 where extremely high inflow potential exists in RED and YELLOW areas and high inflow potential is found in GREEN and LIGHT BLUE areas. In other words, these are highest priority areas of the Village where rainfall induced inflow potential is most severe.

For each of the flow meters analyzed, the inflow due to rainfall is determined as “Average Capture Coefficient”, which is a measure of the amount of rainfall that finds its way into the sanitary sewer mains.

As such, the higher the Average Capture, the higher the potential of inflow into the sanitary sewer mains in a given flow meter area.

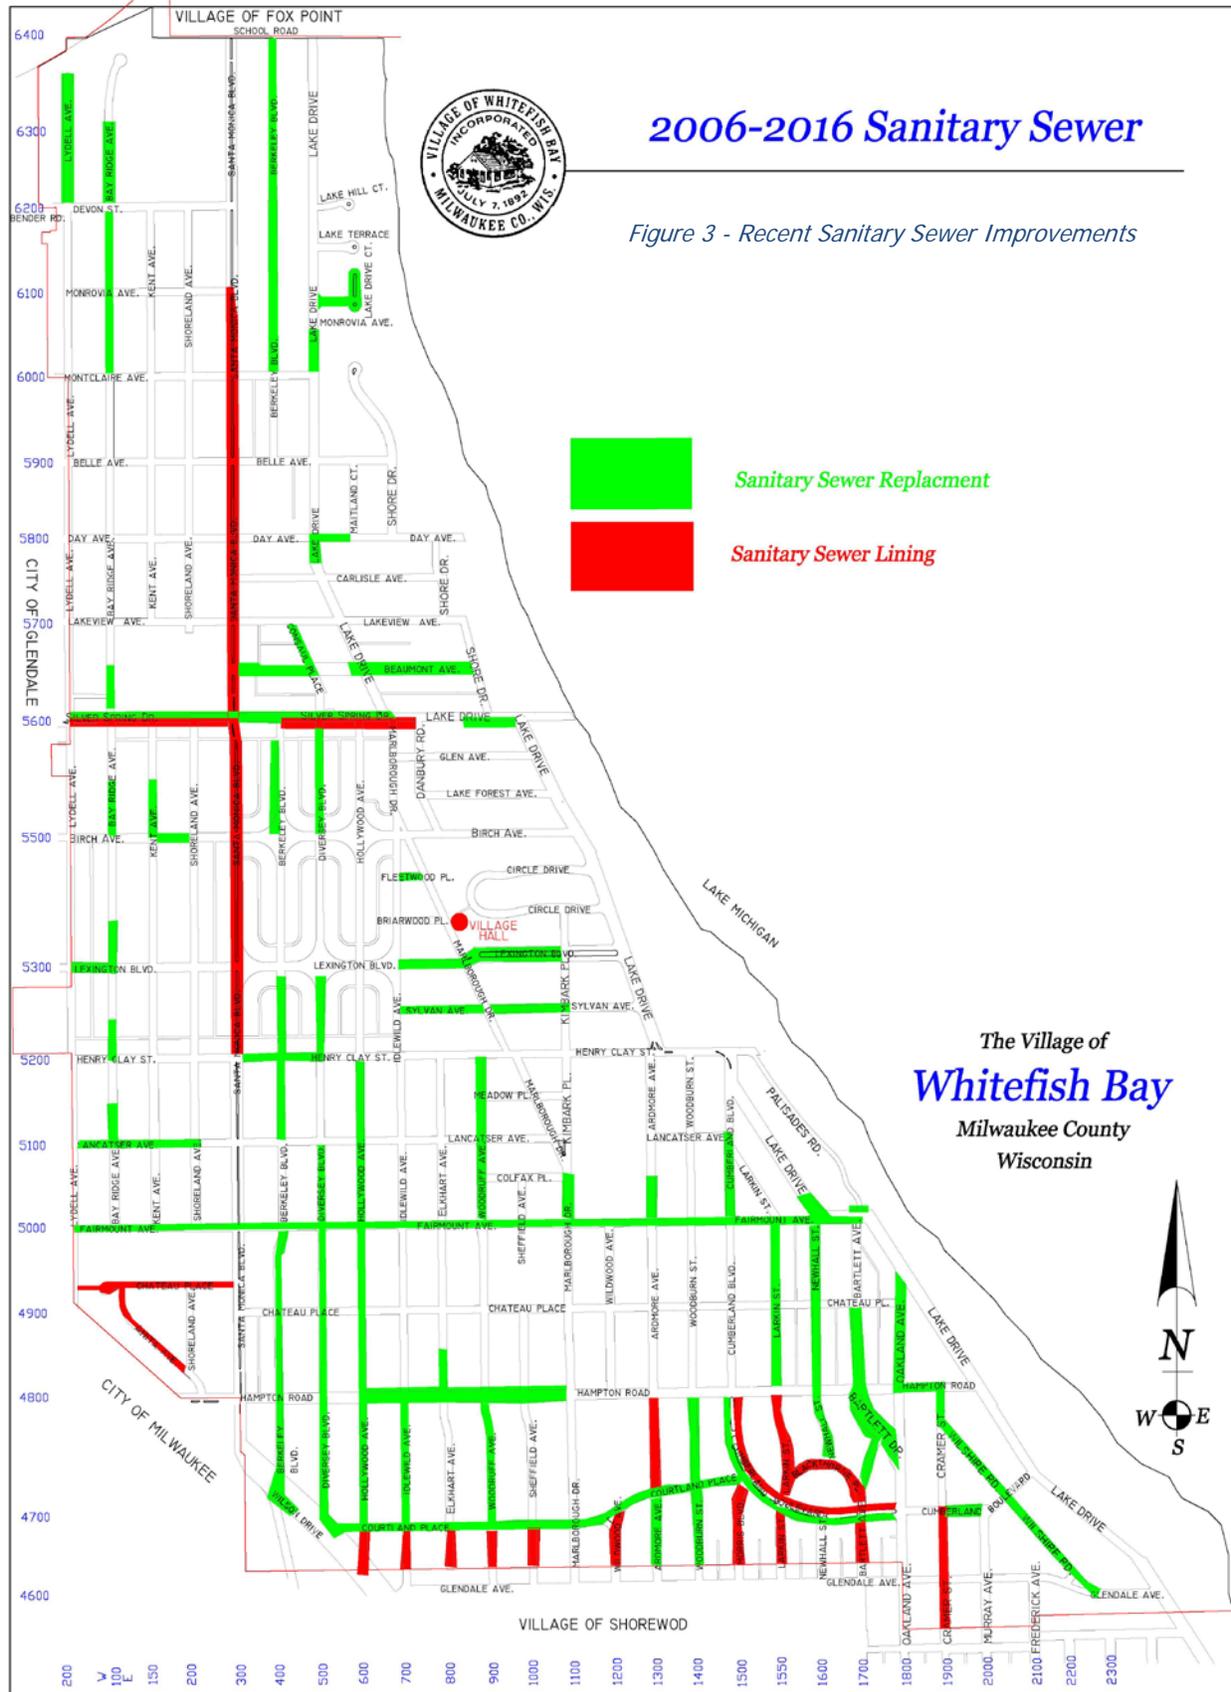
2006-2016 Sanitary Sewer

Each year, Whitefish Bay undertakes the lining of public sanitary sewer mains and the rehabilitation of public sanitary sewer manholes to prevent leaks and seepage of groundwater into the sanitary sewer conveyance system. The significant progress in sewer main improvements in the last decade is shown in Figure 3. The green and red colors indicate streets with improved sanitary sewer mains.

Sanitary Sewer Replacement

Sanitary Sewer Lining

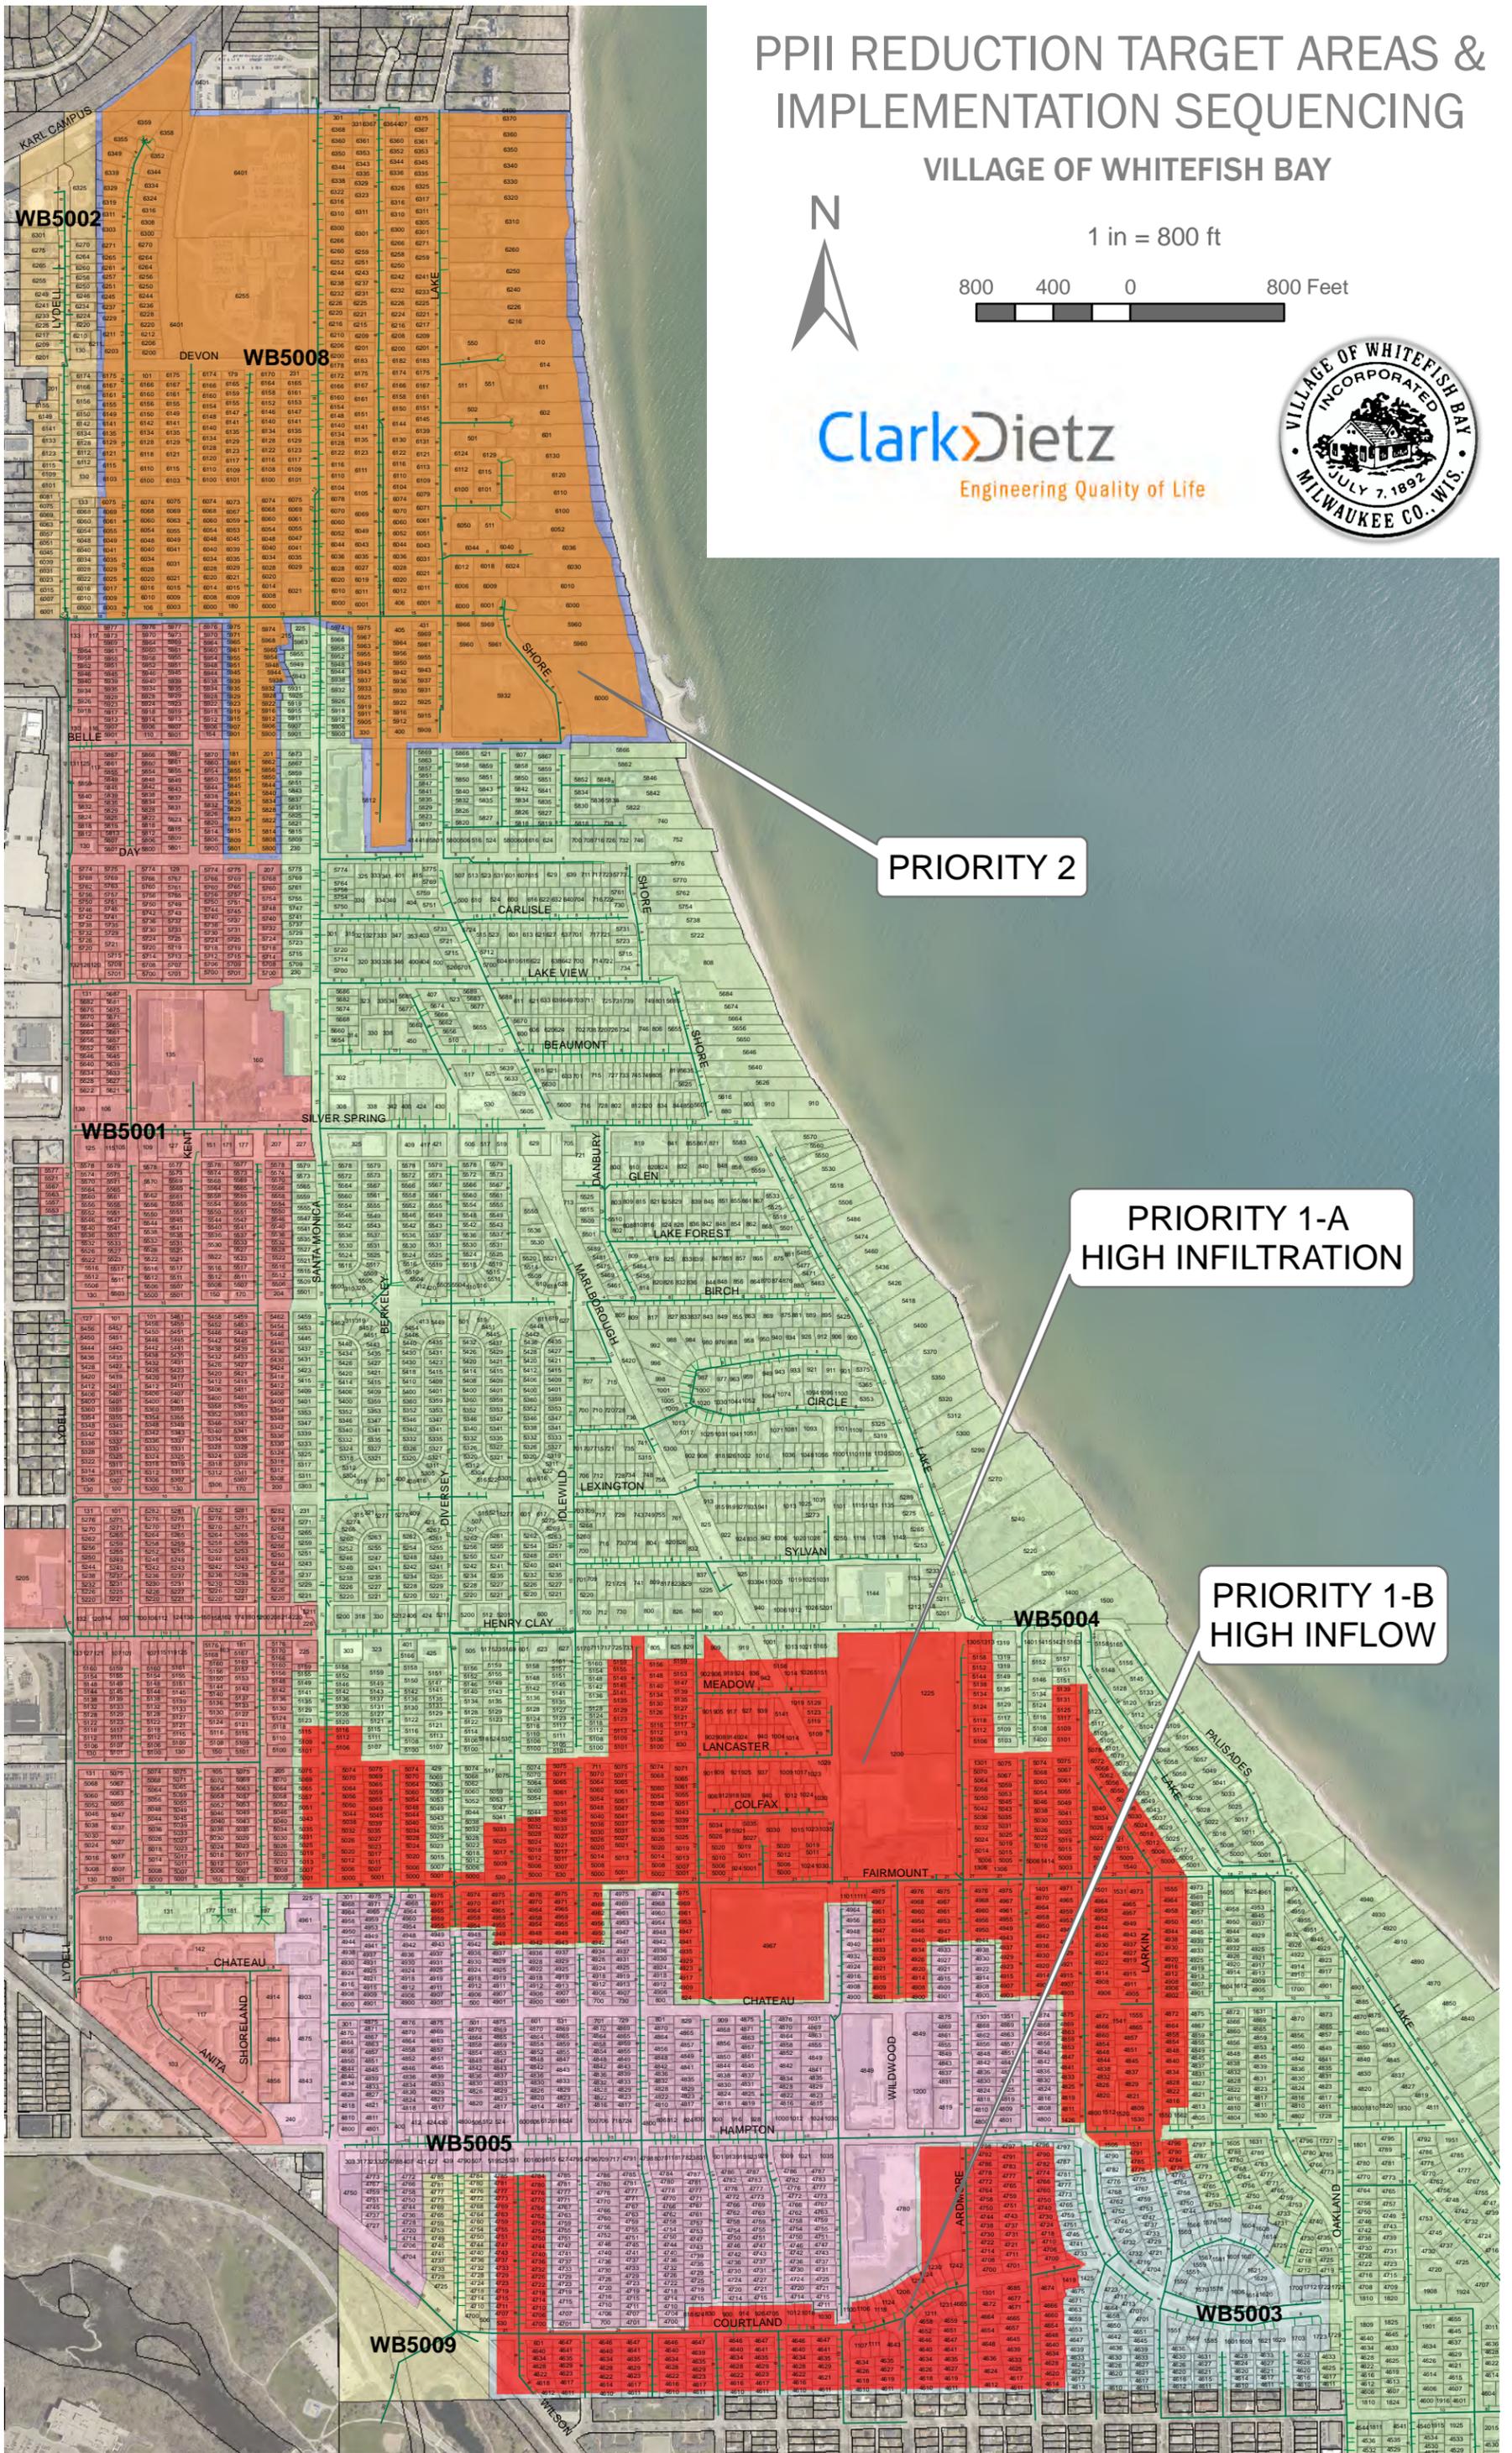
**PRIORITY 1-A
HIGH INFILTRATION**

**PRIORITY 1-B
HIGH INFLOW**

- A. High infiltration area bound by Henry Clay Street, Chateau Place, Diversey Boulevard, and Larkin Street, labeled as Priority 1 – High Infiltration in Appendix 1.

This area is generally bound by School Road, Belle Avenue, Lake Drive and Berkeley Boulevard. Previous studies have found that Sewershed WB5008 (750 properties, 162 acres), indicates a very high degree of inflow during rainfall events. Priority 2 area is shown in Appendix 1.

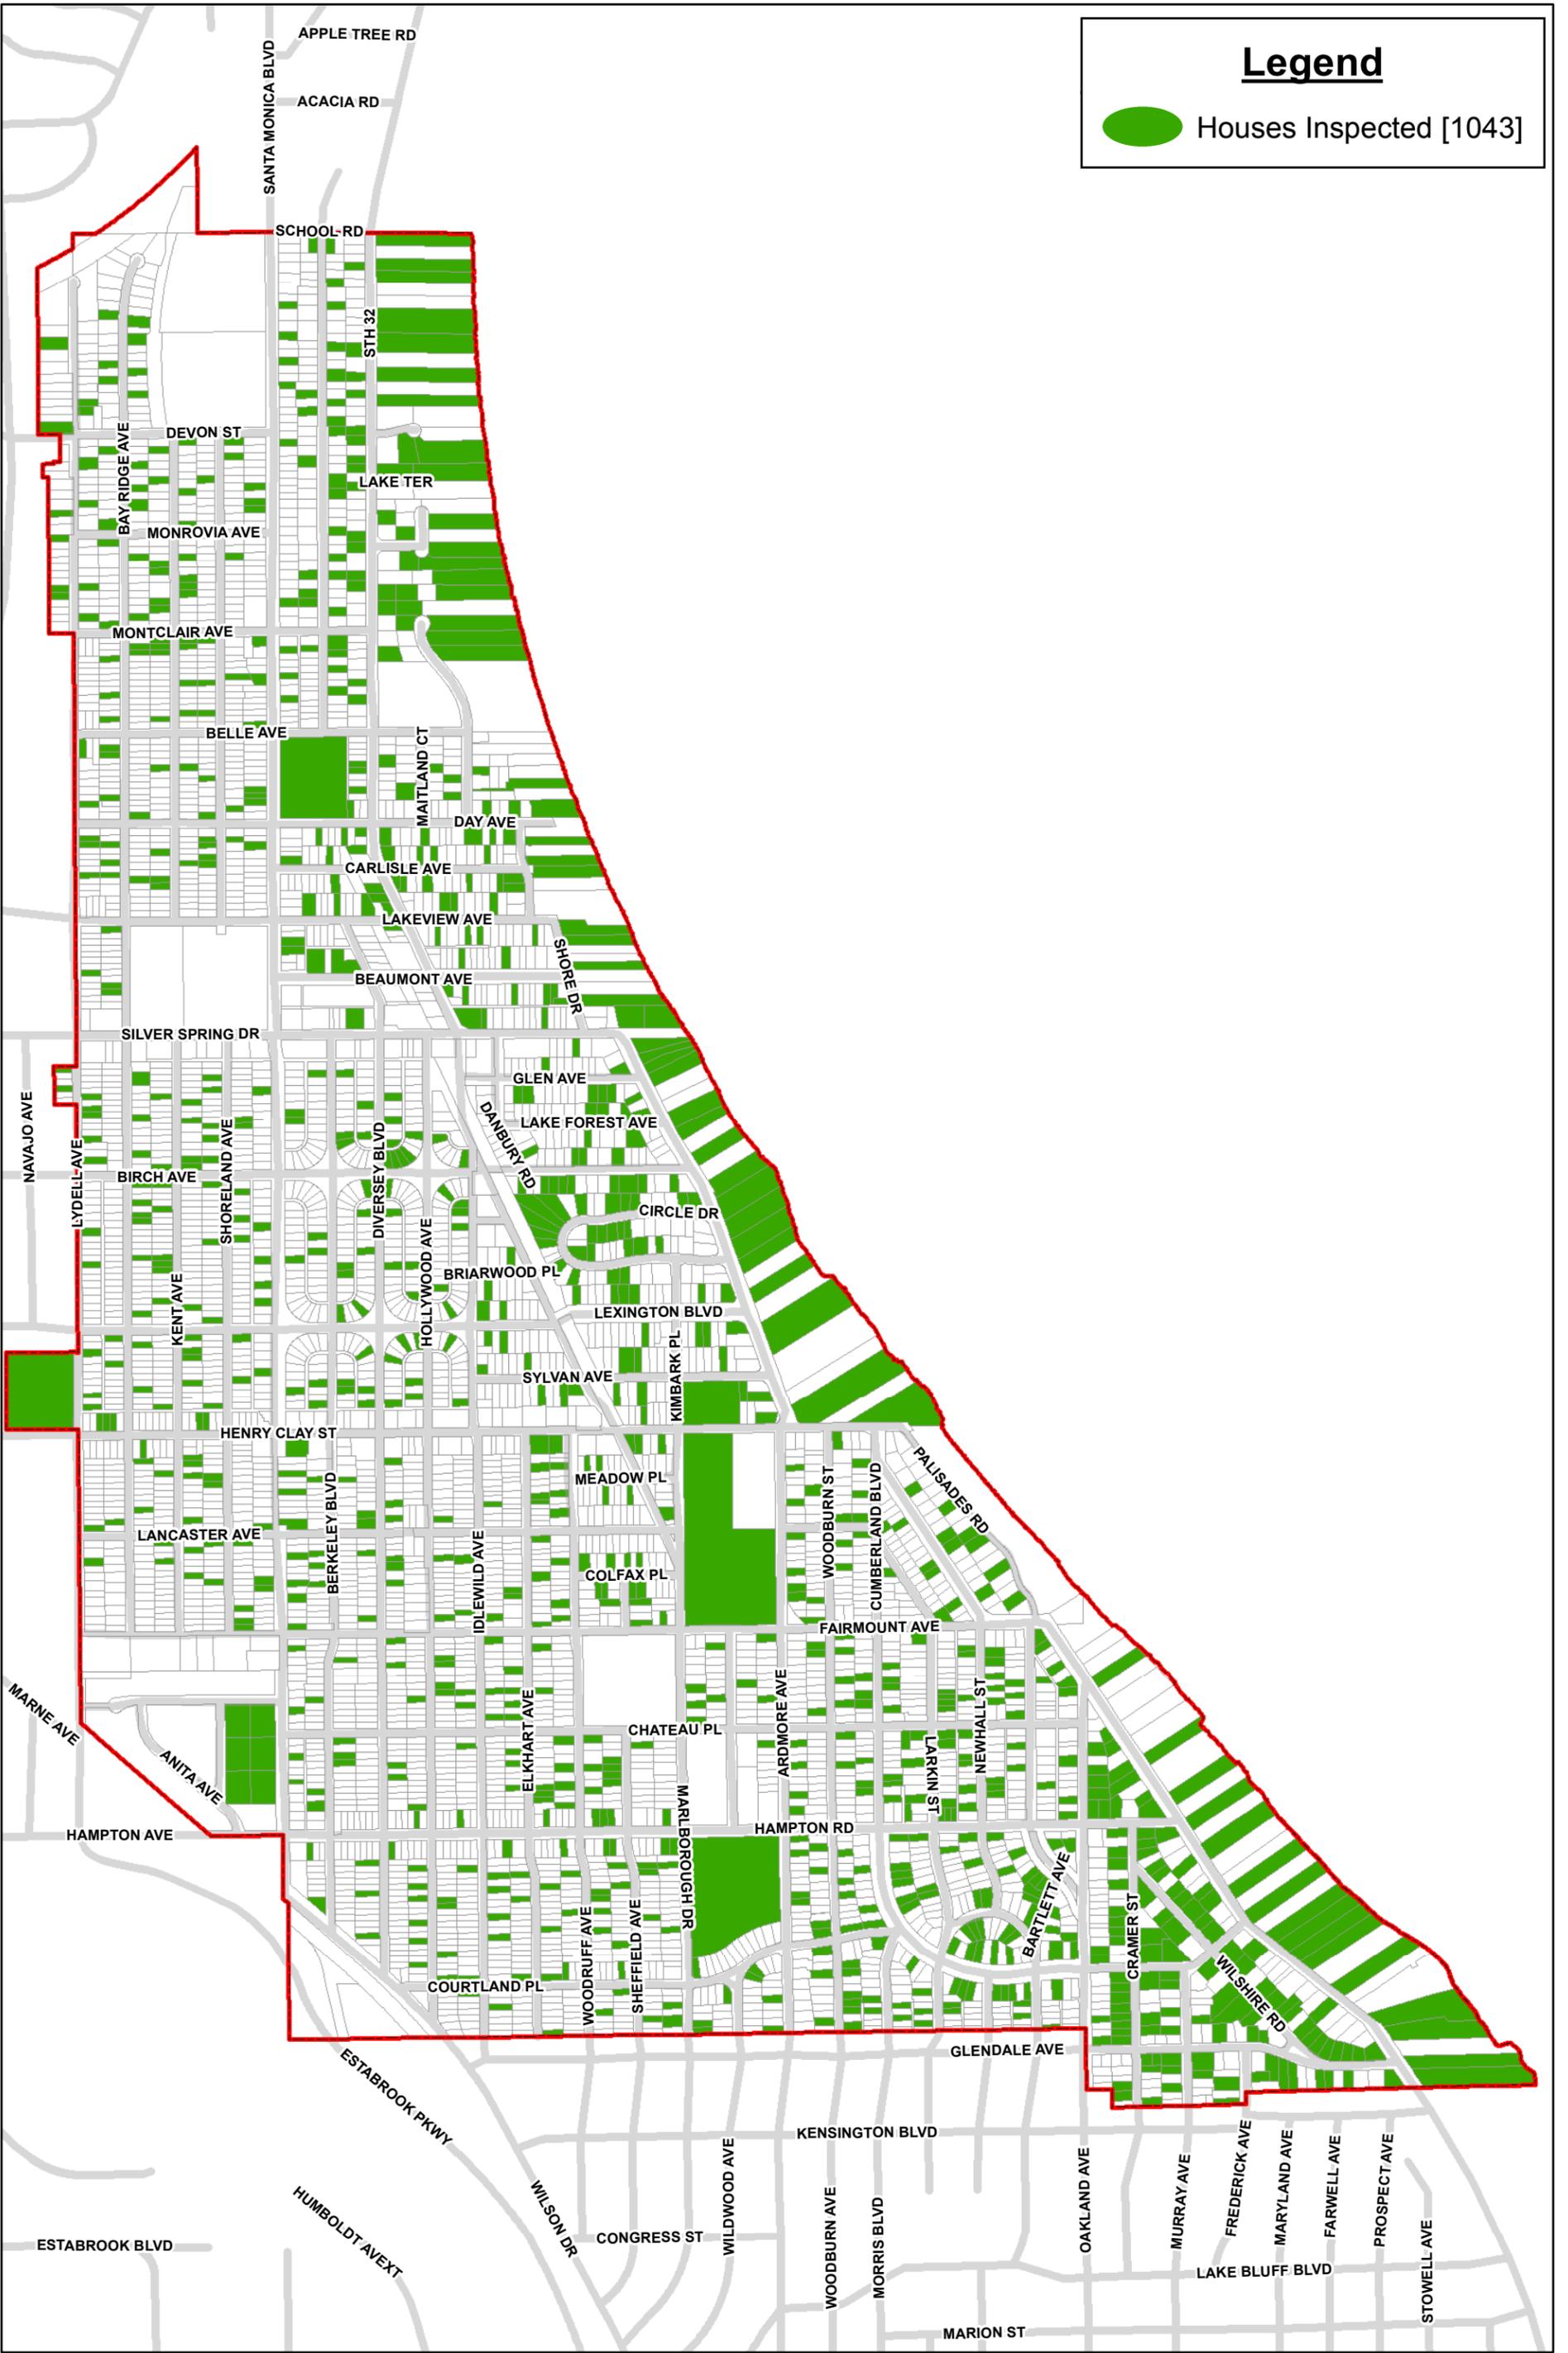
Houses Inspected [1043]

The visual inspections began on September 21, 2013 and were completed October 9, 2013. After the visual inspections were completed and the data compiled it was found that there were a total of 219 residences that displayed that the downspout discharged below surface grade and should be dye water tested.

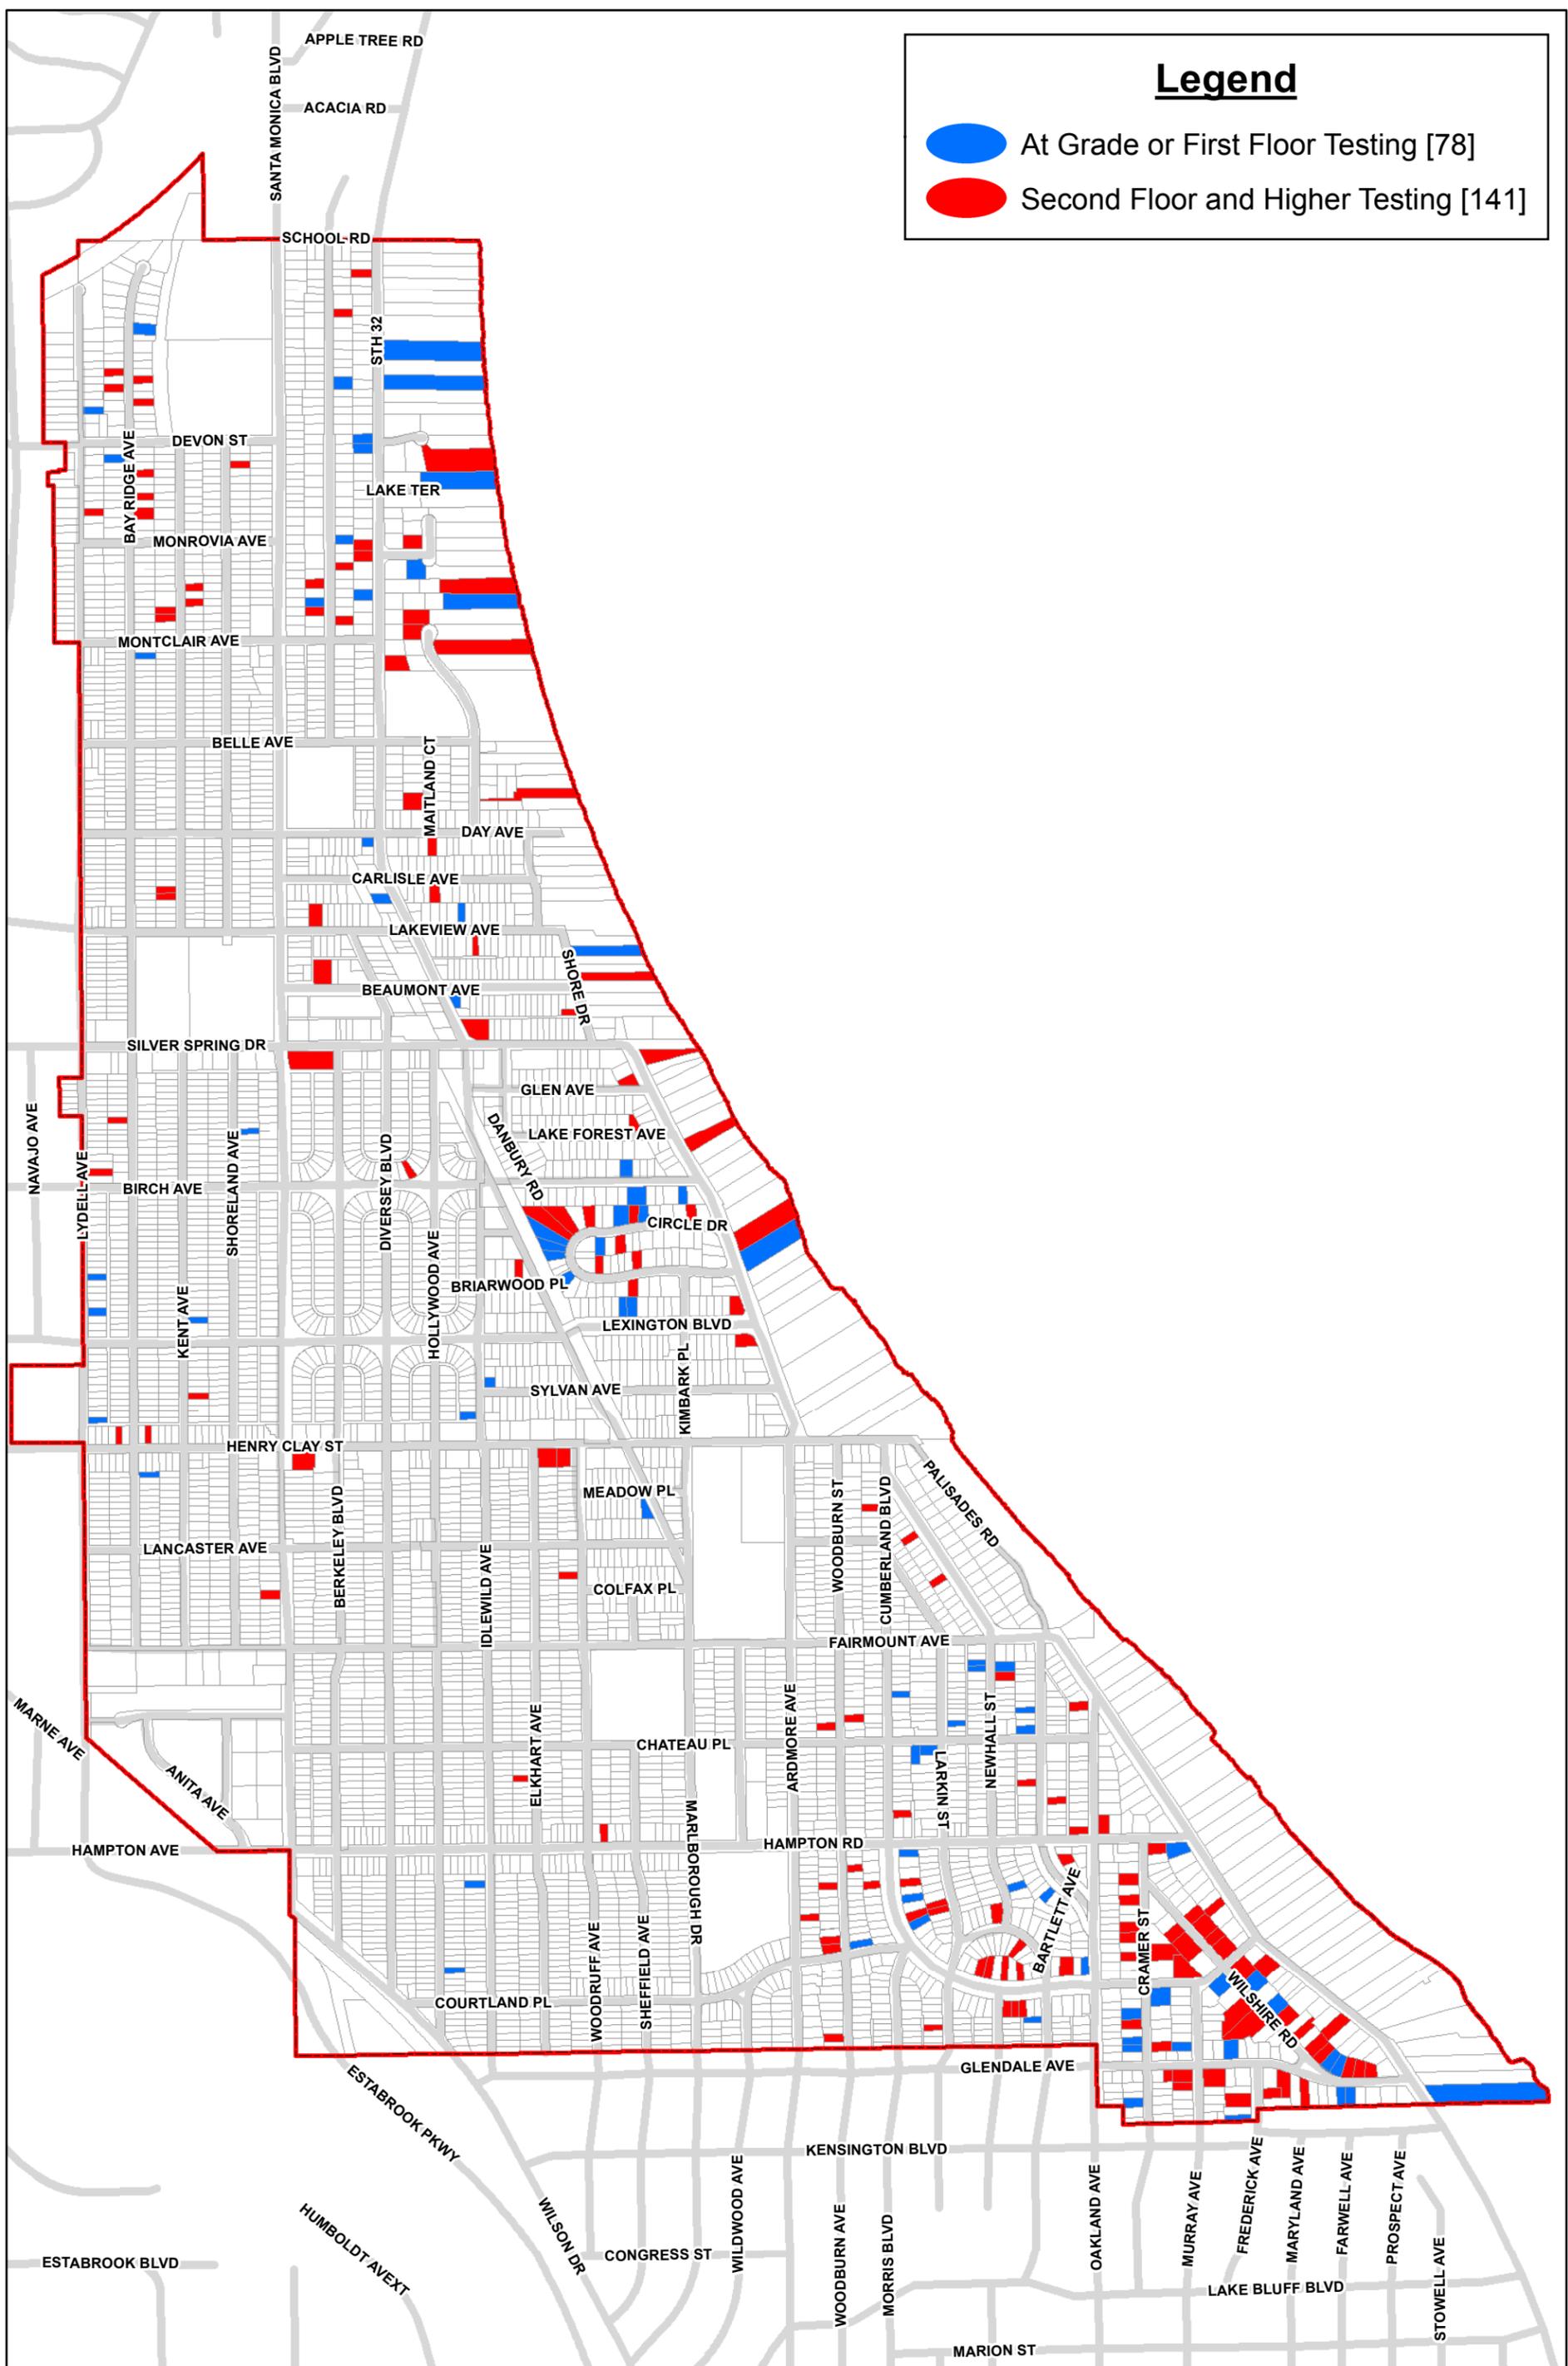
- At Grade or First Floor Testing [78]
- Second Floor and Higher Testing [141]
